**Morning Star Gold NL**

## MORNING STAR GOLD – PROJECTS UPDATE

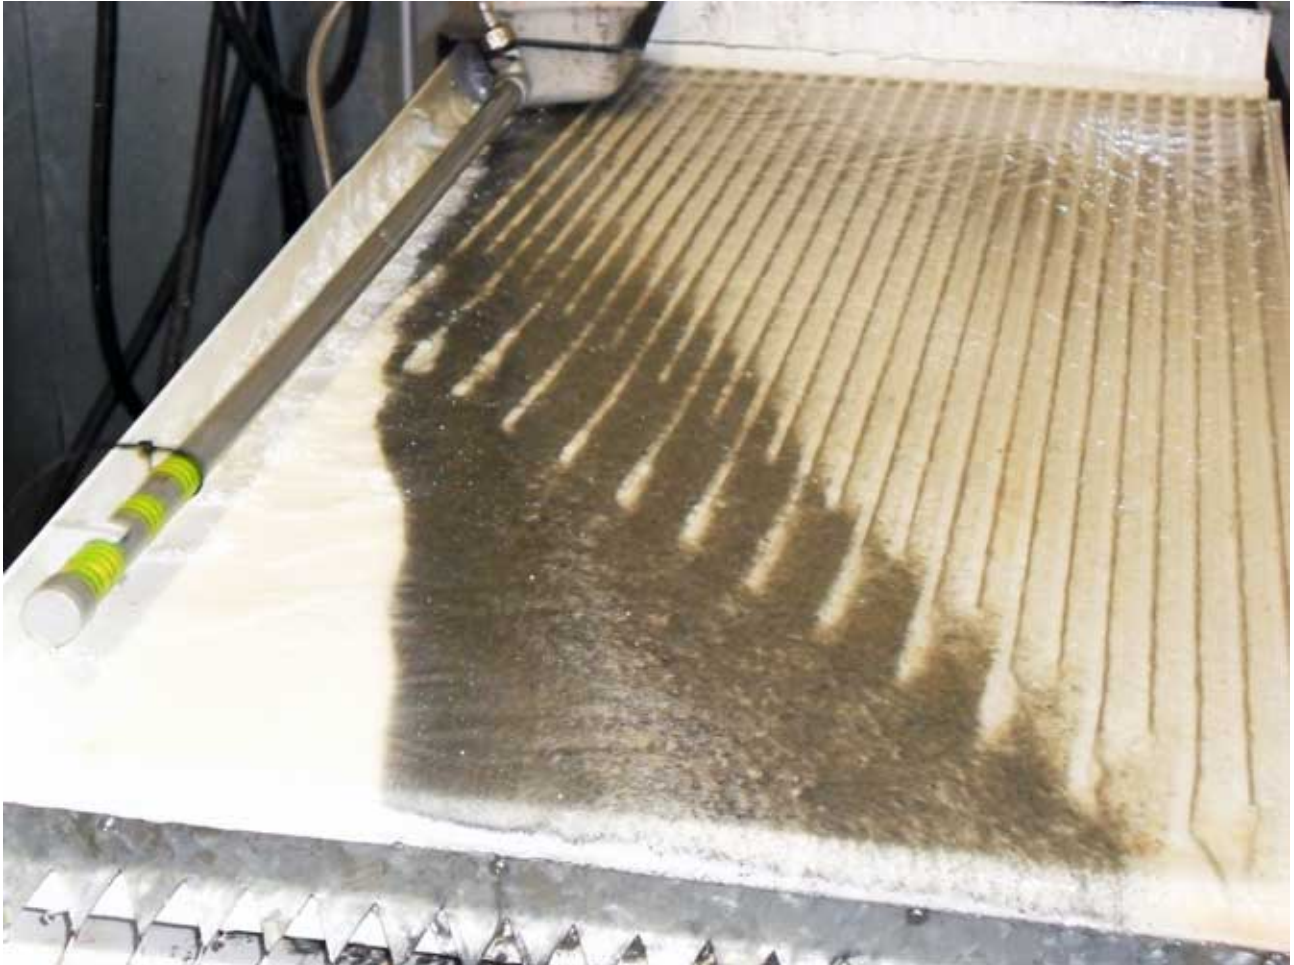
**Photo of Wilfley table at Morning Star's GPP. Smelting has occurred offsite for the first time last week.**

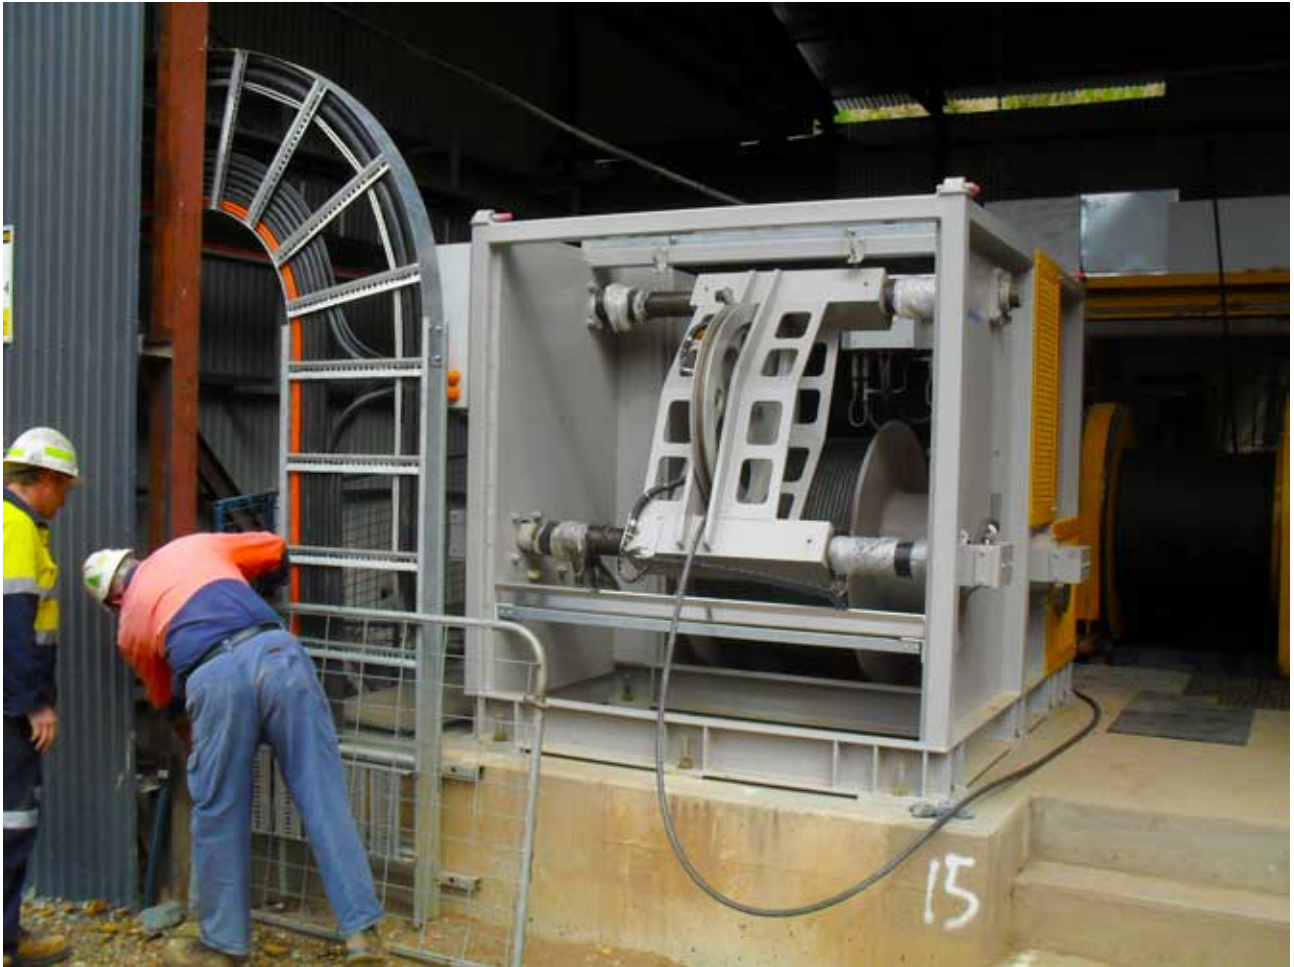
**The new winder is aimed at significant productivity improvements in the main shaft**

As reported earlier this year, once commissioned and coupled with the new haulage cage that is being constructed for MCO and ongoing shaft stability maintenance, the winder will be able to haul ore up the shaft at a rate at least 5 times faster than the old winder. The new unit is computer controlled and is designed so it can be easily upgraded in the future to allow fully automated haulage of ore should cost benefit analysis of this make the case clear to upgrade the haulage at the Morning Star goldmine further still.

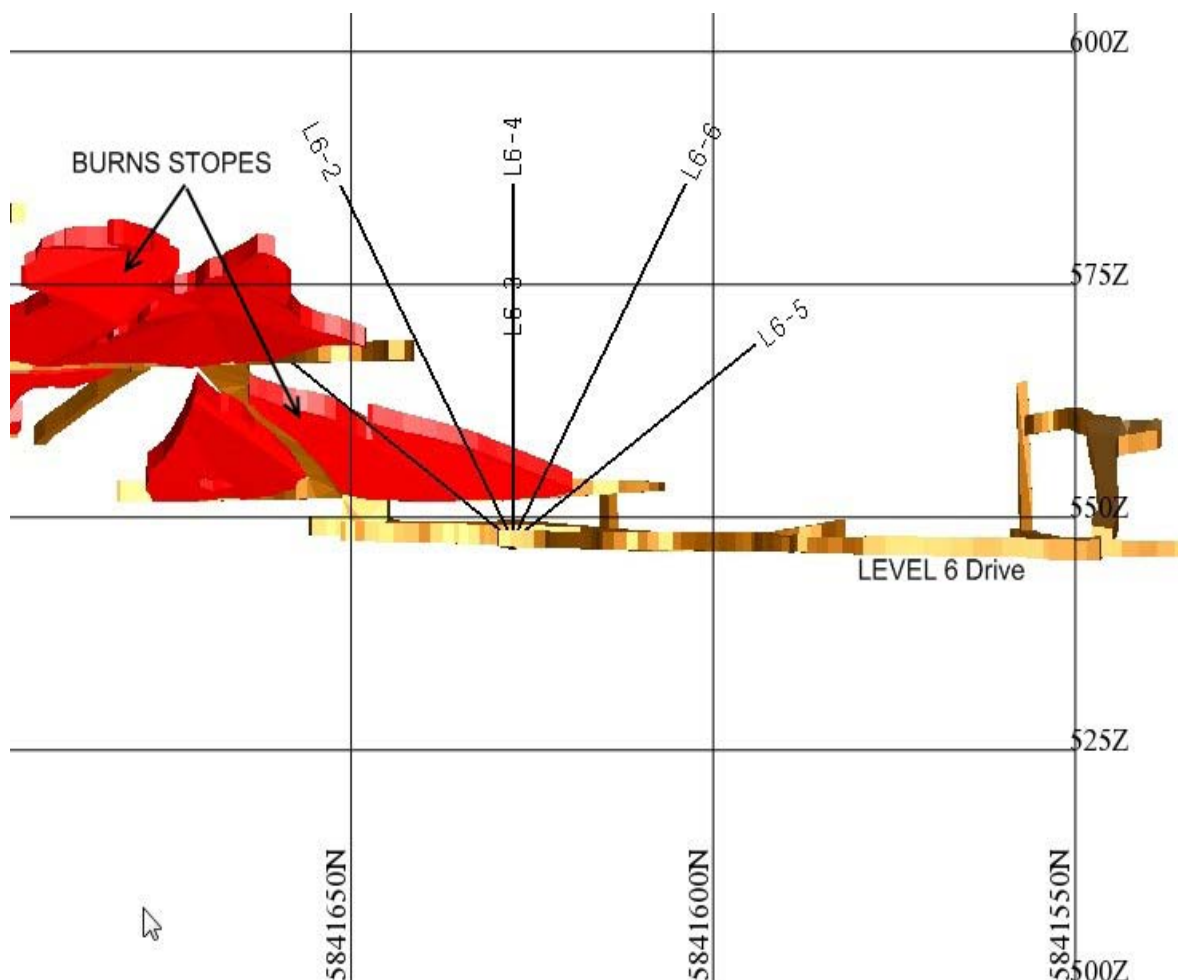
Hole L6-2 is being drilled along the same plane as L6-1 but at a steeper angle and is planned to intersect the same two potential mineralised zones and to date has not reached the first target zone. *See plan of drilling below:*

MCO has commenced a program of six planned holes in the historically high-grade Burns Reef zone from the 6 Level of the Morning Star mine (~180 metres depth). This is the first underground diamond-drilling program at the Morning Star mine since the Maxwell and Kenny Zones were discovered some 70-100 metres deeper in 2008. Drill hole (L6-1) has been completed and L6-2 is commenced with the drilling being planned to enhance the current expanding mining plans and add to the in mine resources.

L6-1 was drilled to test the southern extension of the Burns reef above the 6 Level drives and a narrow quartz reef, surrounded by intense hydrothermally altered gabbro dyke host rock was intersected where the hole was planned to pass through the Burns reef. L6-1 was then continued on to the eastern contact of the gabbro and the dyke sediment where more hydrothermally altered dyke material was encountered. MCO is awaiting assays for these two zones.

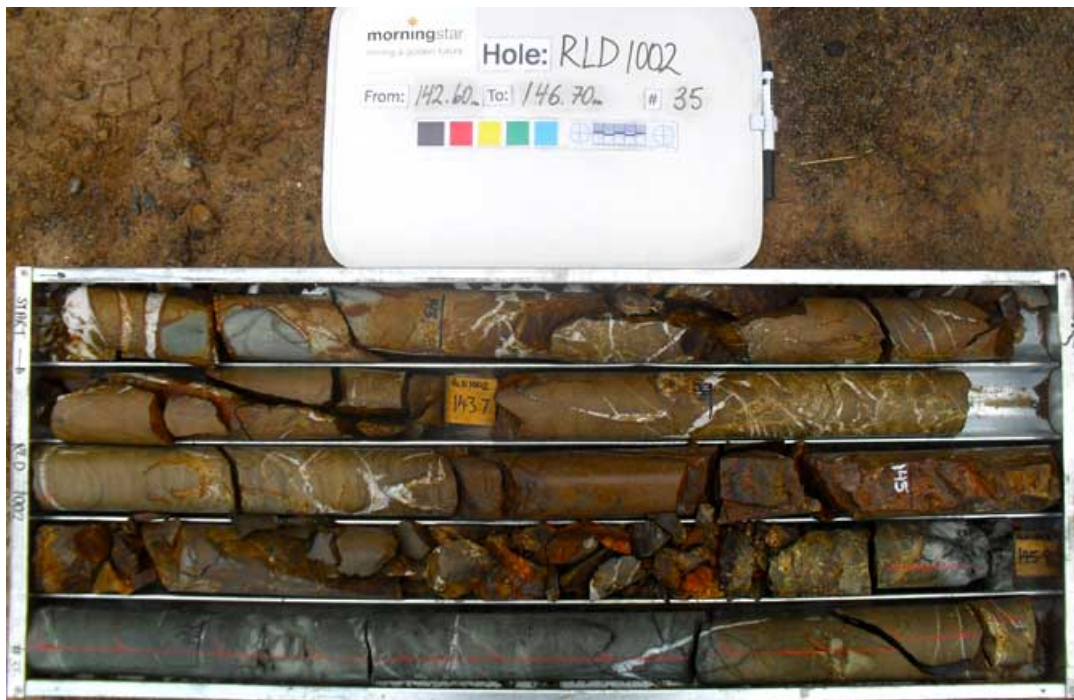
Image of Reliance Hole 2 (RLD1002) showing drill core & alteration

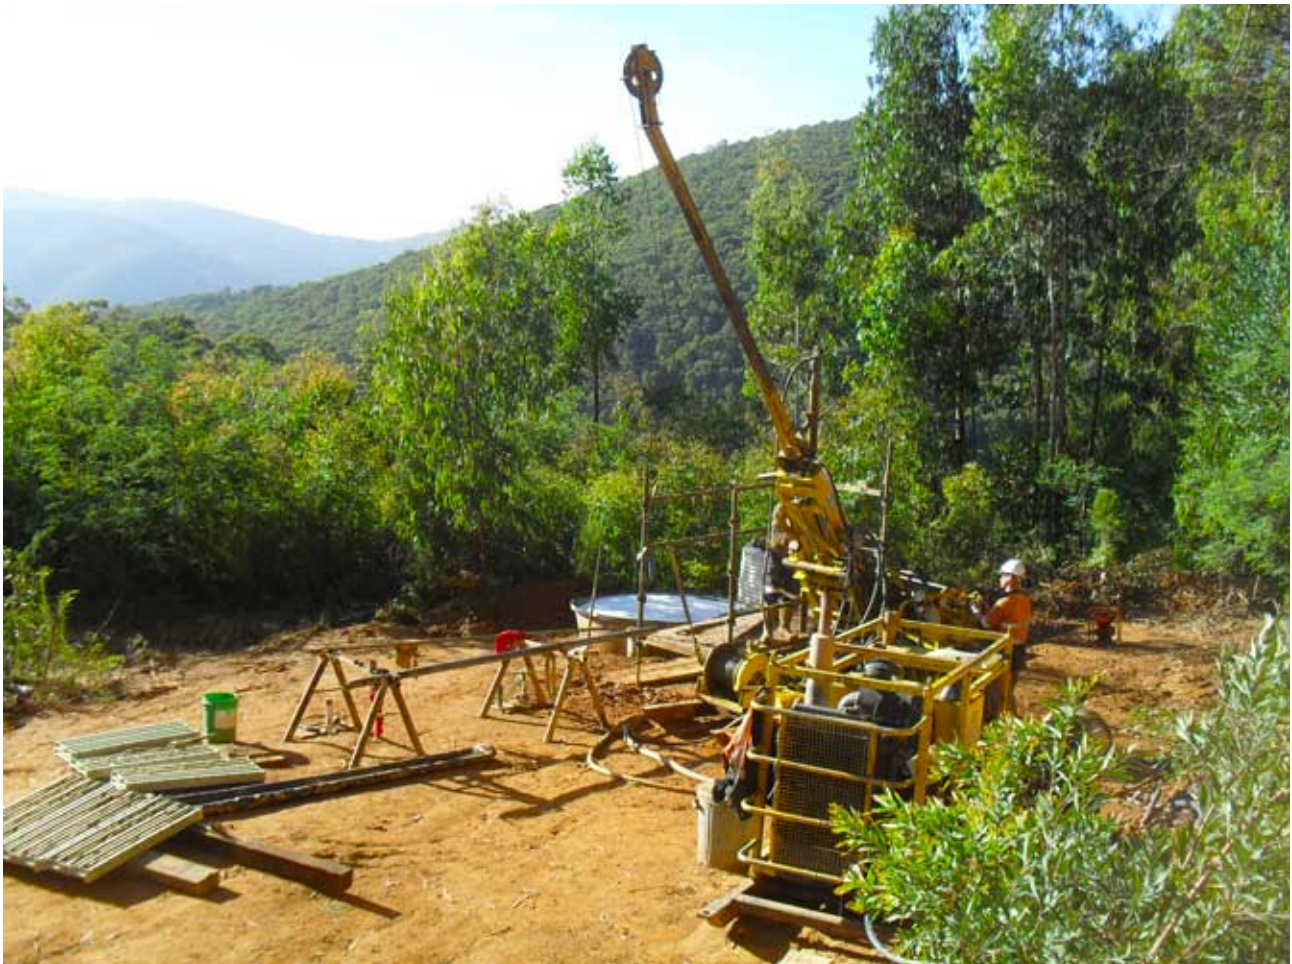
Drilling from surface of Morning Star dyke into AAA reef zone of Morning Star goldmine

A surface diamond drill hole (MSD 1101) was started last week to test a known zone of mineralisation located between Level 1 and Level 4 known as the 'AAA' reef zone.

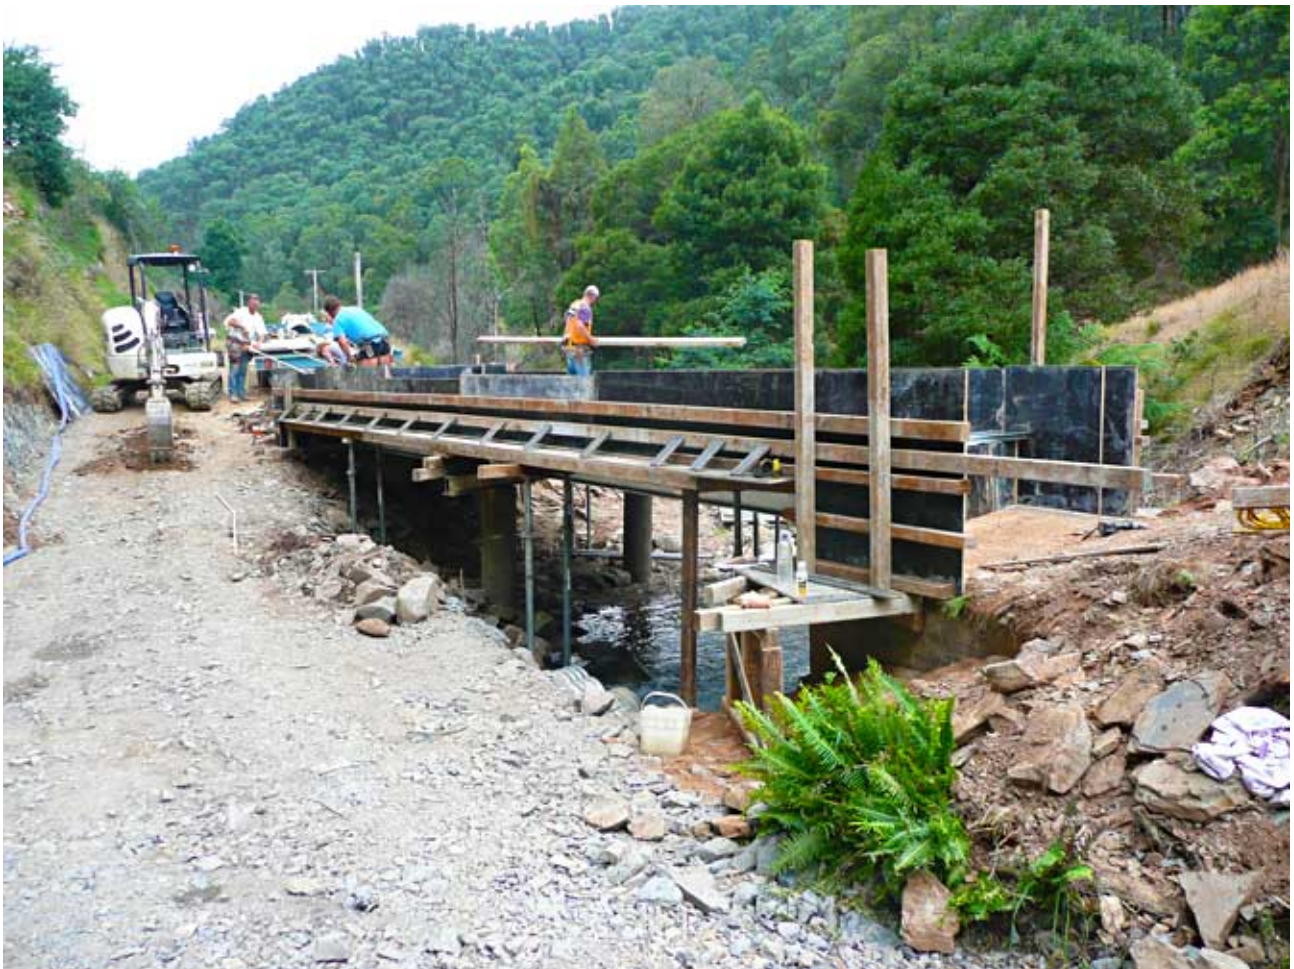
Significant upgrade works on the main bridge over Cannon's Creek into the RoD project area at Paradise Point have been completed. The bridge works will allow for heavy machinery and trucks to pass safely over the creek and provide better amenity to the local community and residents as well. *See image below of bridge reconstruction by MCO:*
